# The Road Inventory of Buenos Aires National Wildlife Refuge Sasabe, AZ

Prepared By:  
Federal Highway Administration  
Central Federal Lands Highway Division  
March 2008

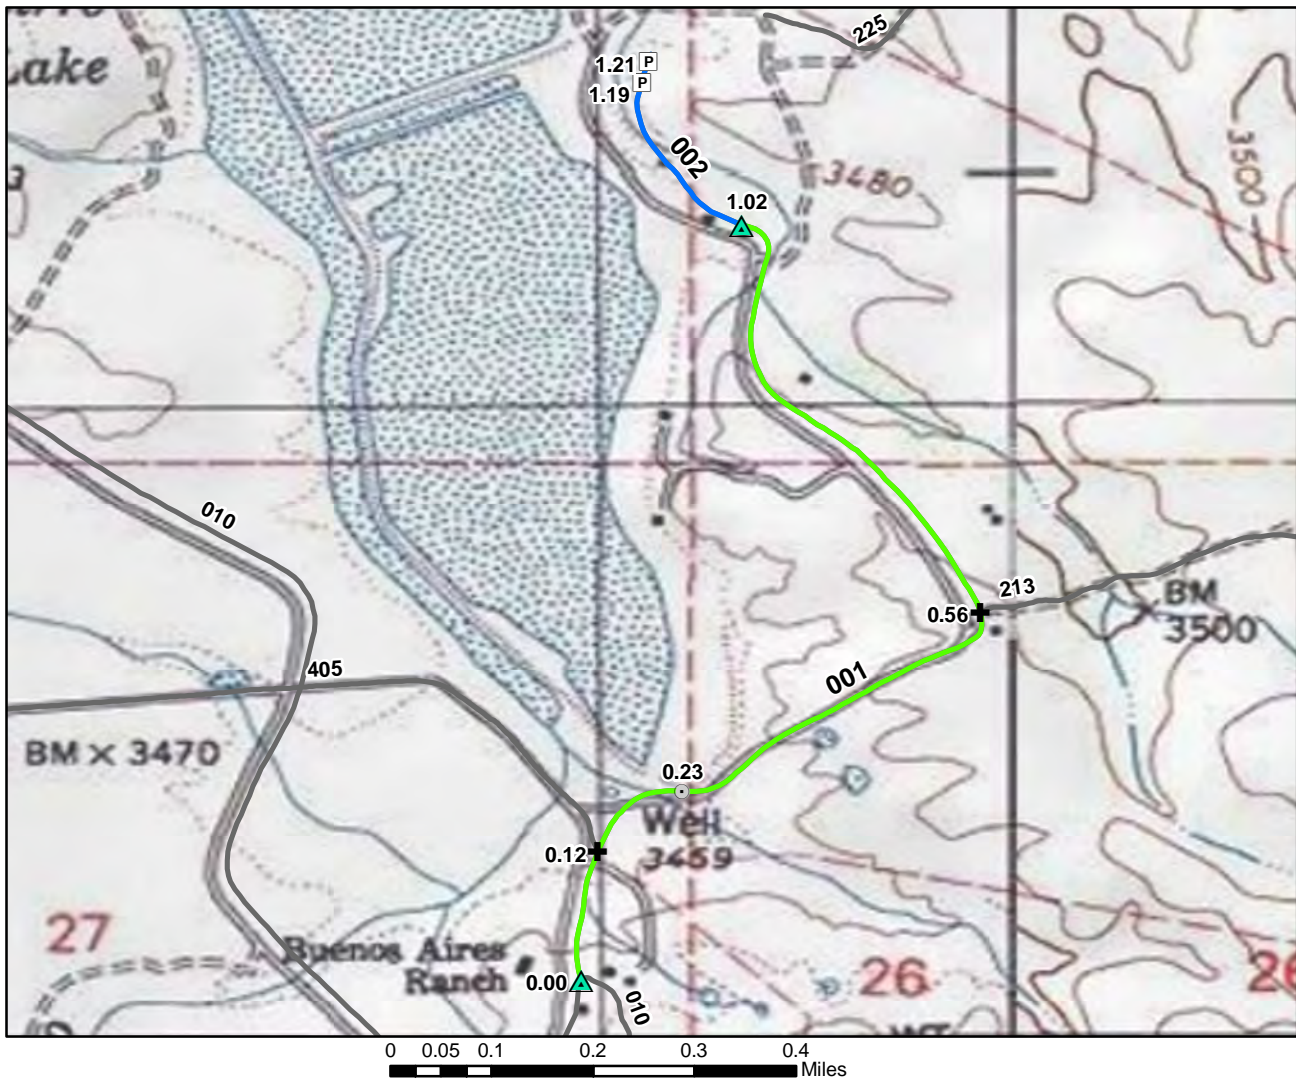
Section Number	016				
Section Length (miles)	0.61				
Inspection Date	3/25/2004				
<b>Section Information</b>					
Surface Type	Native				
Number of Lanes	1				
Roadway Width (feet)	11				
<b>Roadway Condition Information</b>					
Condition	Failed				
Remaining Service Life (years)	0				
Cost Estimate	\$74300				
CRV	\$215900

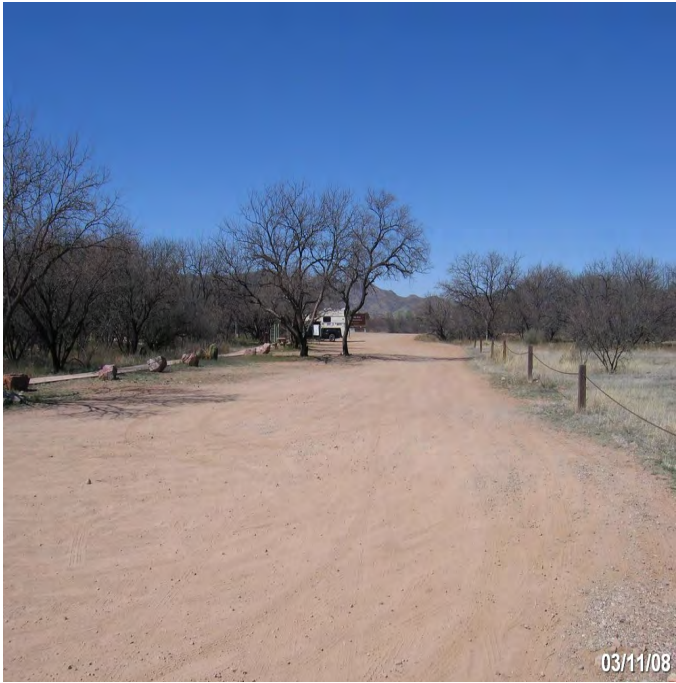
Asset Number	Date Visited	Surface Type	Area (sq ft)	Condition	Cost to Improve
10041241	3/12/2008	Gravel	18950	Poor	\$20600
